**APPLICATION FOR A DLNR DAM SAFETY  
CONSTRUCTION/ALTERATION PERMIT  
PERMIT NO. 34 - OPAEULA RESERVOIR NO. 1 (HI00018)  
RESERVOIR REPAIR, HALEIWA, OAHU**

## ENGINEERING REPORT

# Opaeula Reservoir No. 1 Dam Improvements Waialua, Haleiwa, Oahu, Hawaii

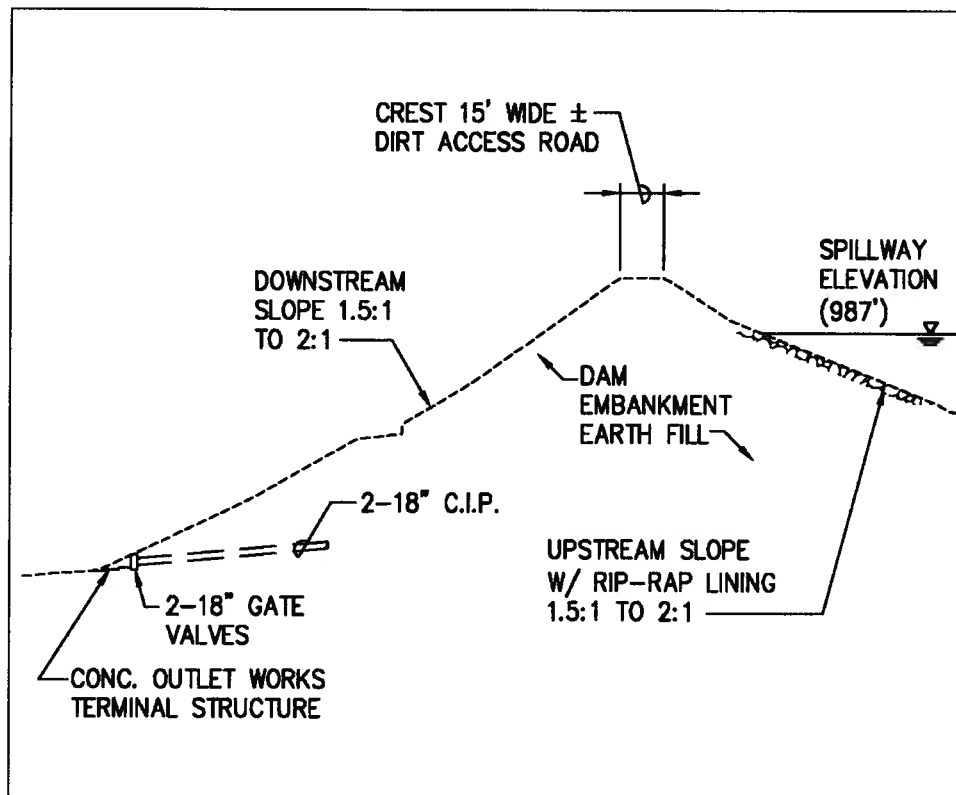
Figure 3-1: Existing Dam Section

The dam is an earth fill structure with a crest length of approximately 250 feet and a crest height varying from 20 to 71 feet. The dam has a crest width which varies from 10 to 15 feet. The upstream slope of the dam was constructed at a slope gradient of about 2:1 (horizontal to vertical) and is lined with riprap. The downstream slope was constructed at slope gradients ranging from 1-1/2:1 to 2:1, with the steeper portions nearest the crest. A generalized cross section of the dam is presented in Figure 3-1.

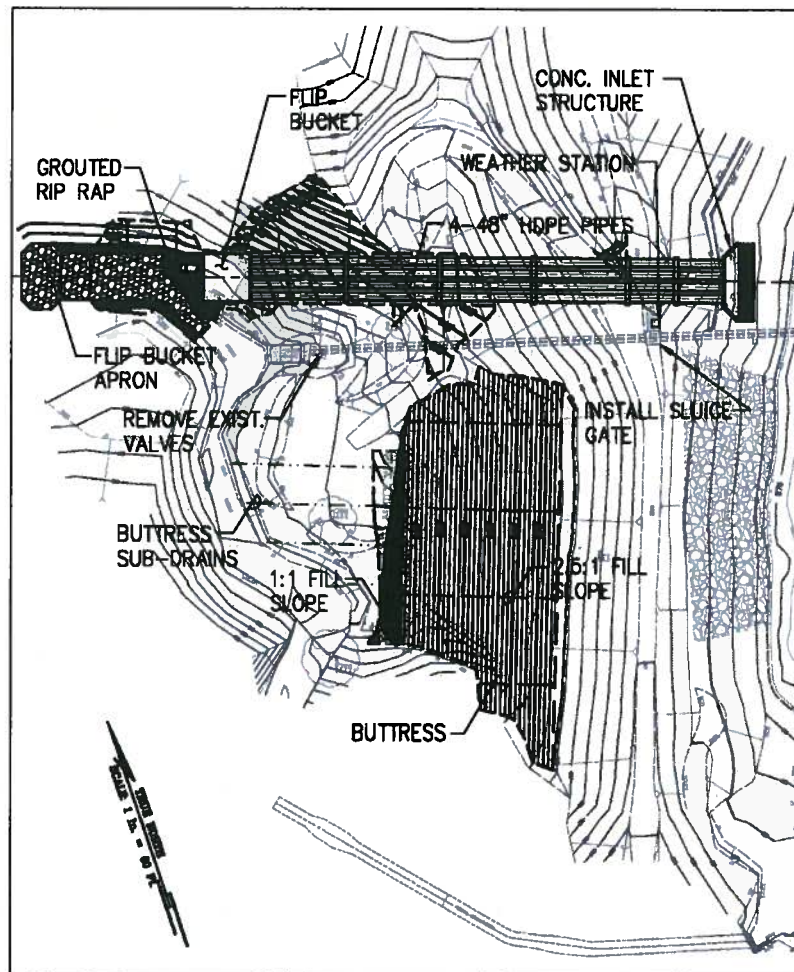
Figure 4-1: Proposed Improvements

The objective of this project is to improve the operational and safety characteristics of the dam. The improvements will be done to meet the minimum design standards in accordance with the current Hawaii State Dam Safety Regulations addressing the operations and structural integrity of the dam. The spillway capacity of the dam will be improved to handle the required storm event peak flows. The hydraulic controls of the dam will be upgraded to provide safer operation and improved control of water flowing in and out of the reservoir. The dam stability will be improved with the use of an earth buttress.

The proposed spillway will be located on the north side of the dam buttress. The spillway will consist of approximately 244 lineal feet of four 48-inch outside diameter (O.D.) high density polyethylene (HDPE) pipes buried inside the dam abutment, parallel to the existing outlet works. The four pipes will be encased in concrete. For the proposed improvement

layout, see Figure 4-1. The proposed spillway will work in conjunction with the existing tunnel spillway to convey a design storm flow (1/2 PMF) of 975 cfs. The invert of the proposed spillway will be set at elevation 983 ft, and the invert of the existing spillway is at 987 ft. As the water surface exceeds the top of the proposed spillway pipes which is set at 986.5 ft, water will begin to flow through the existing spillway when the water level hits 987 ft. The proposed and existing spillways will convey about 664 cfs and 311 cfs, respectively. The maximum headwater elevation, during the design storm, will be 994.4 ft. The minimum dam crest elevation is 998.3 ft. See Appendix B for detailed calculations.

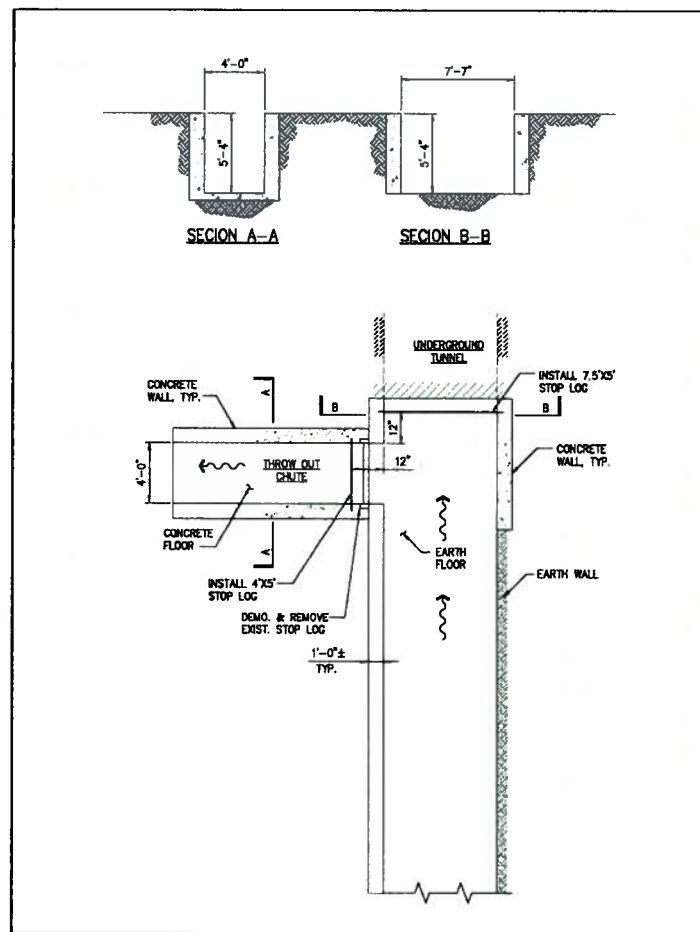
#### Figure 4-4: Inlet Works Throw-out

The Opaepala Ditch Tunnel feeds the Opaepala 1 Reservoir. During a large storm event, the inflow from this ditch will result in a higher peak flow than would occur from the localized drainage watershed alone. To control the water level in the reservoir and control storm surges, the flow of water entering the reservoir can be diverted at the existing throw-out once the throw-out has been reconstructed.

Removable stop logs will be installed at the main ditch channel and at the throw-out channel (Figure 4-4). With the stop logs in place at the main channel and removed from the throw-out channel it will be possible to divert the water into the throw-out channel which empties into a nearby gulch. However, under normal conditions, the stop logs will be in place and blocking the throw-out channel with the main channel fully opened to keep water flowing to the Opaepala 1 Reservoir. See Figure 4-5 for the location of the throw-out channel.
